# Service Bulletin

## SAFETY RECALL

### 2002-2005 VFR800/A Wire Harness Replacement

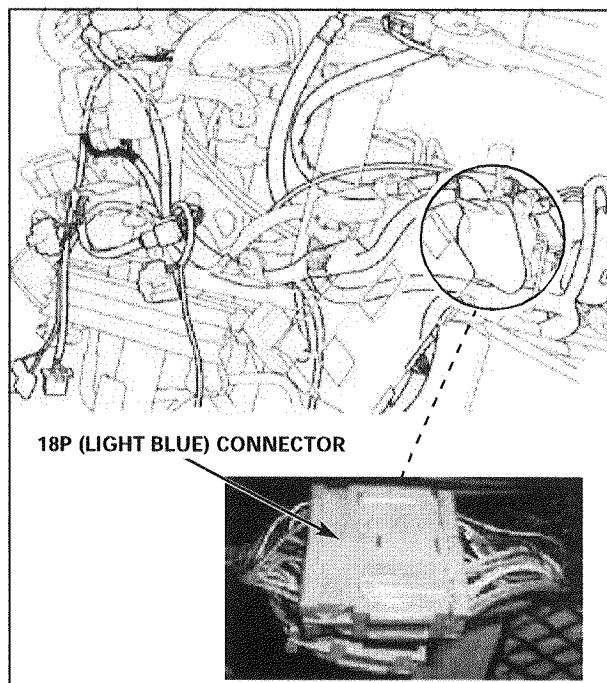
Inspect the 18P connector (light blue) inside the protective sleeve for any burnt, melted, or discolored condition.

**NOTE:** If the 18P connector (light blue) is melted, unable to disconnect, or modified, contact TechLine at (800) 421-1900, option 9, prior to starting the repair.

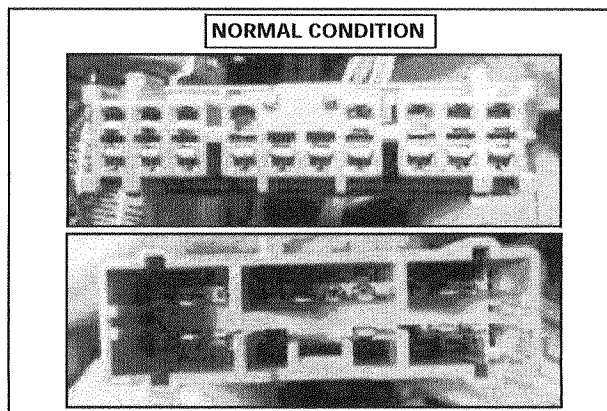
If the condition of the 18P (light blue) connector is normal, proceed with the FRONT SUB-HARNESS REPLACEMENT.

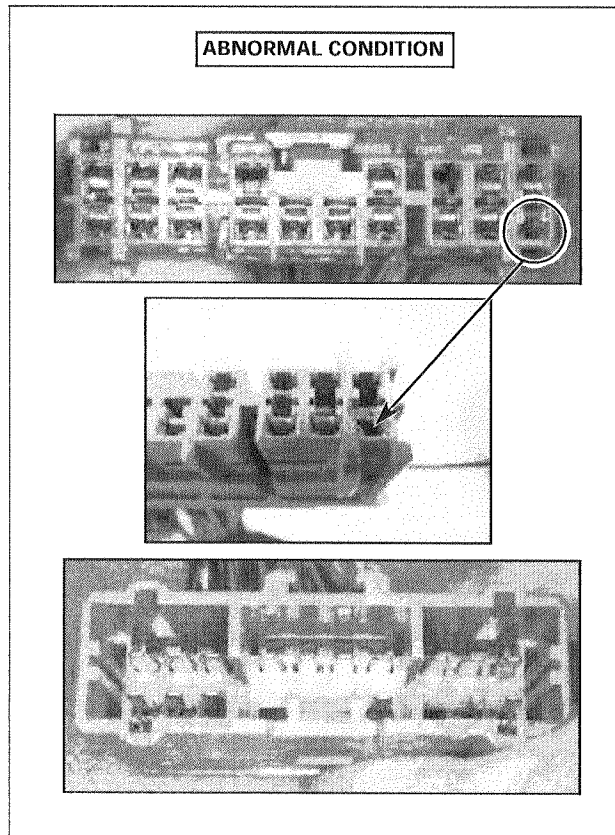
Under certain conditions, the ground wire terminals inside the connector between the main wiring harness and fairing sub-harness can overheat, resulting in melting of the connector and a loss of power to various circuits. As a result, a loss of critical lighting or engine power could occur without warning, which could result in a crash.

If the 18P (light blue) connector is in abnormal condition as shown below, contact TechLine at (800) 421-1900, option 9.
