Service Bulletin

SAFETY RECALL

2002-2005 VFR800/A Wire Harness Replacement

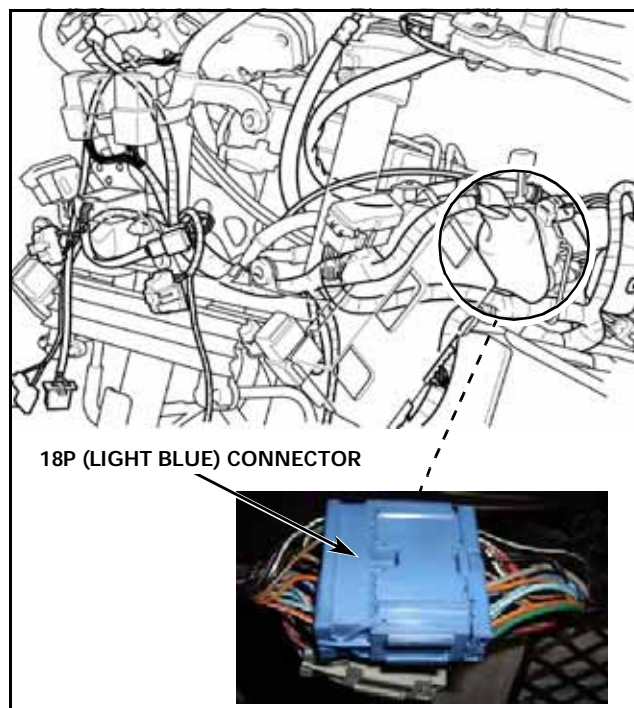
Inspect the 18P connector (light blue) inside the protective sleeve for any burnt, melted, or discolored condition.

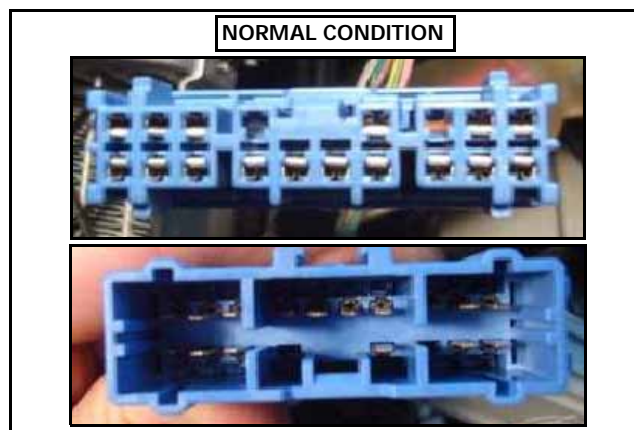
If the condition of the 18P (light blue) connector is normal, proceed with the FRONT SUB-HARNESS REPLACEMENT.

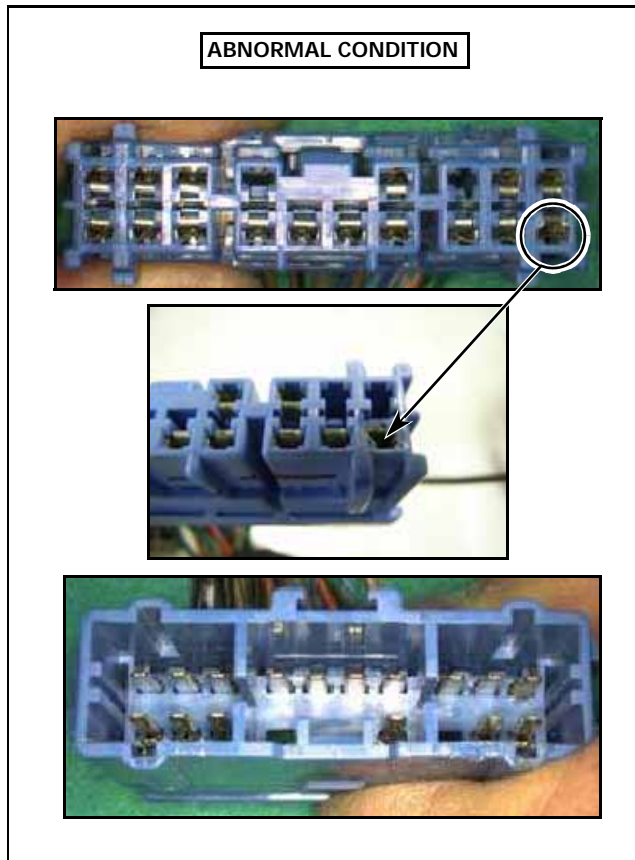
If the 18P (light blue) connector is in abnormal condition as shown below, contact TechLine at (800) 421-1900, option 9.

NOTE: If the 18P connector (light blue) is melted, unable to disconnect, or modified, contact TechLine at (800) 421-1900, option 9, prior to starting the repair.
